**Re: Landslide Area Deviation Request Information
 Point Wells Redevelopment
 Unincorporated Snohomish County, Washington
 17203-54**

**A-37 Landslide Area Deviation Request Clarification Letter 5.15.2018
PFN: 11 101457 LU**

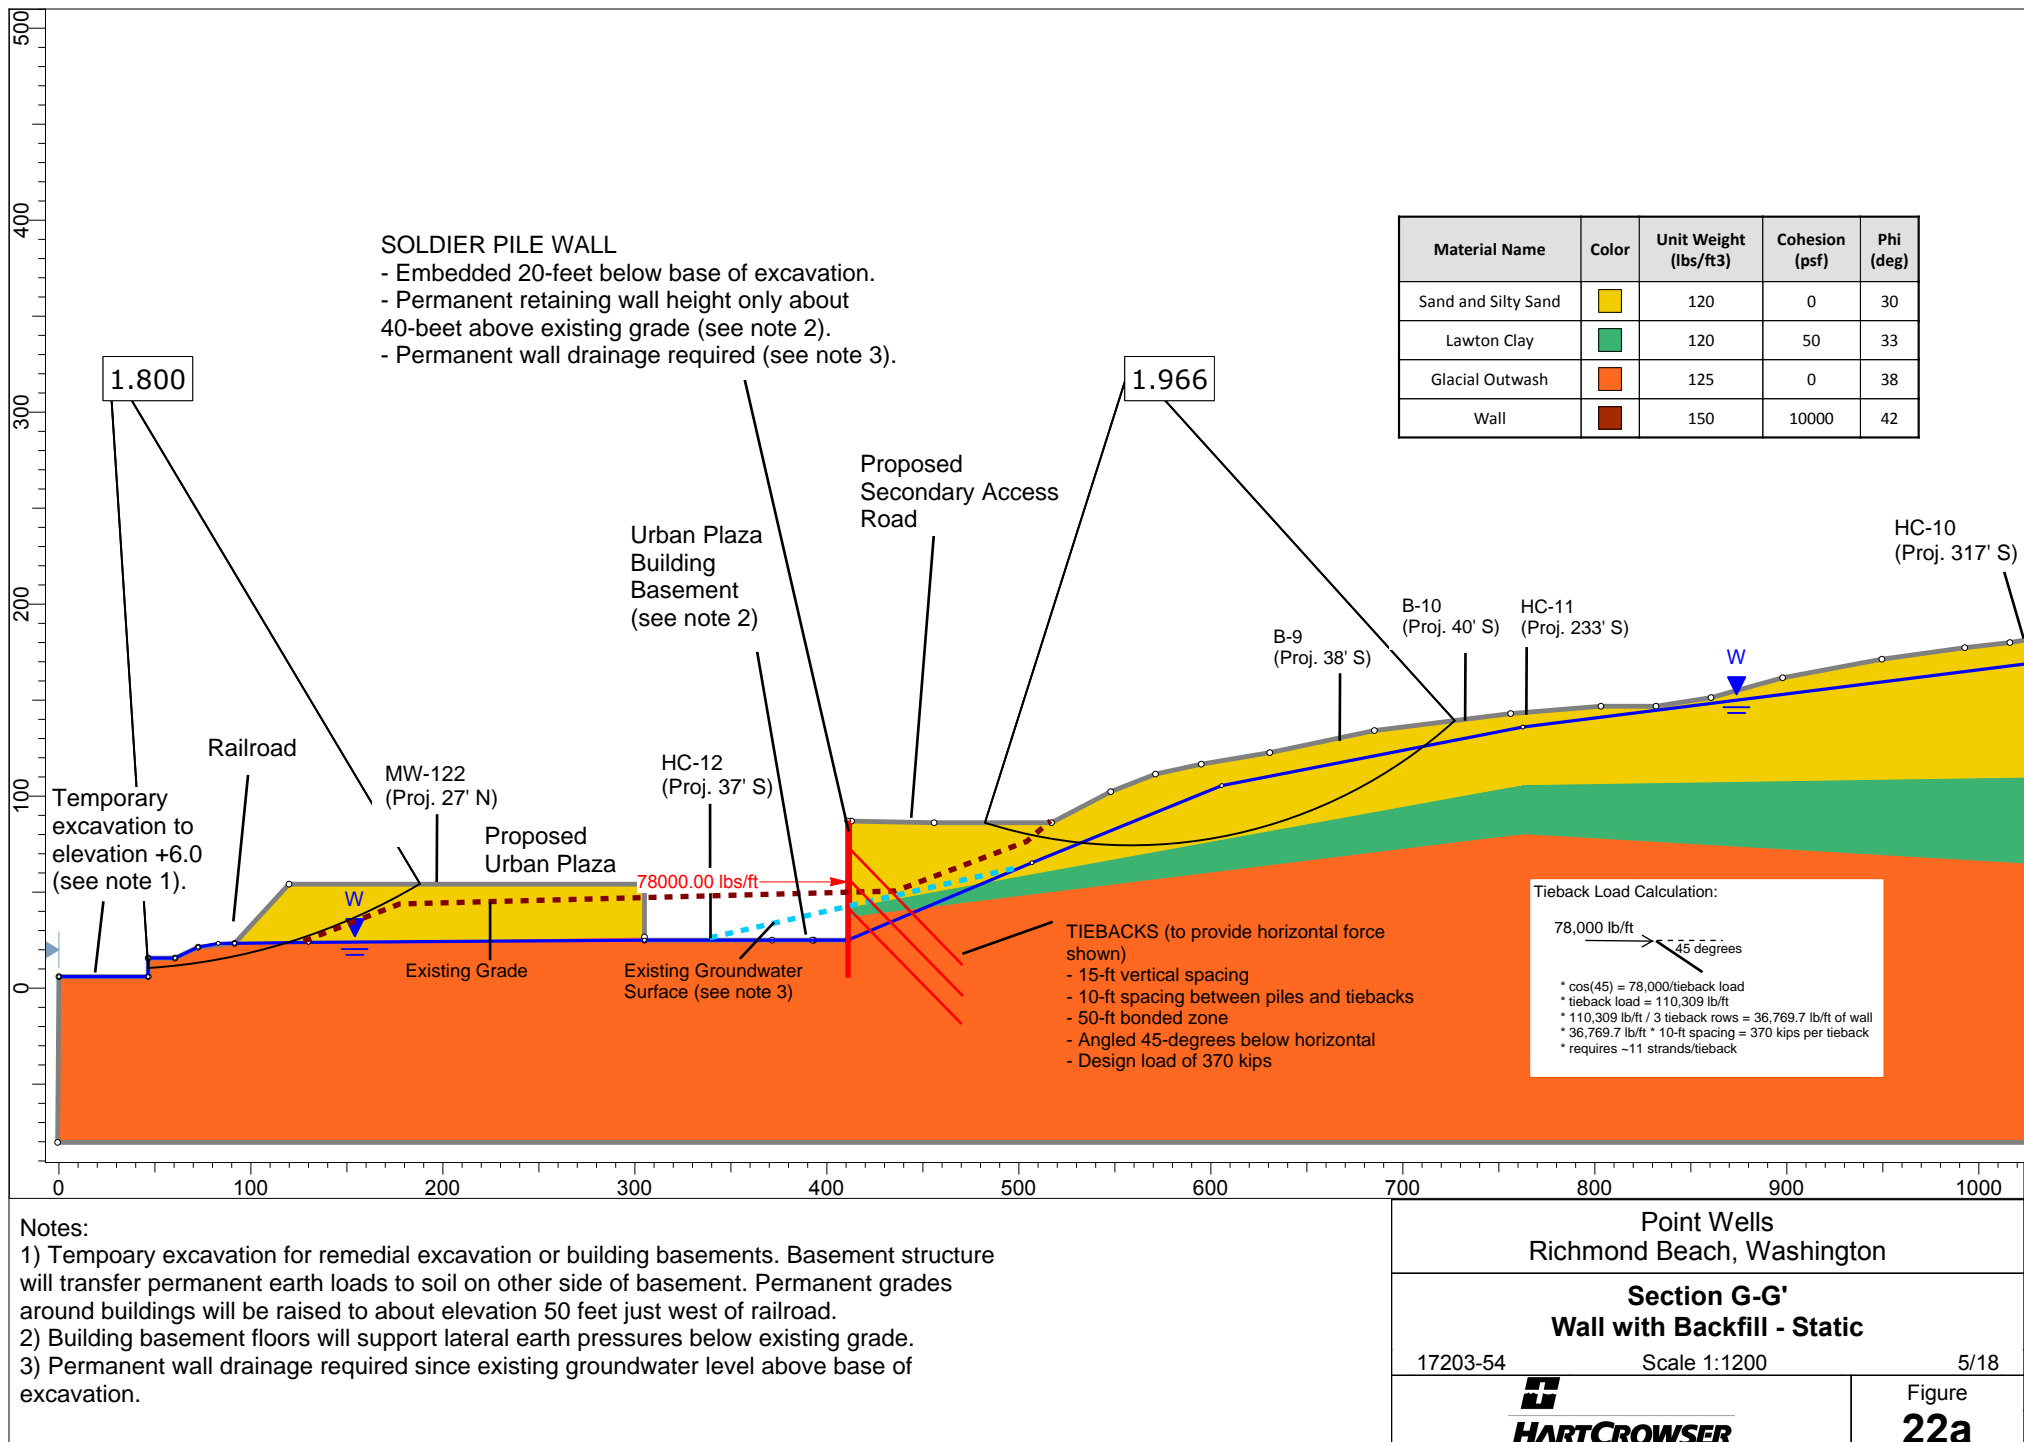
Figure 22a - Section G-G' Wall with Backfill - Static

- The retained height of the retaining wall (Figures 22, 22a, 23, and 23a; ‘a’ designates updated figures in the addendum letter) permanently supports about 40 feet above final grades. The lower 20 feet below grade would be for building basements and lateral earth pressures would be supported by basement floor slabs transferring.

- Geotechnical slope stability analysis/calculation results Figures 22 to 23 (including 22a and 23a) show how a generic retaining wall providing 78 kips/foot of wall of resisting force achieves the required County factors of safety. Several retaining wall options could be used. Figures 22a and 23a of our addendum letter demonstrate how a permanent soldier pile and tieback retaining wall system is feasible to provide these loads (includes soldier pile and tieback geometry and loads).

- Figures 22a and 23a include excavation west of the railroad to elevation +6 feet, showing factors of safety above the required values. See our May 2018 addendum letter for a more detailed discussion.
